**Initial Investigation of the Cause of Salinisation
of Dam Water Supplies and their Management,
at the Bodhinyana Buddhist Monastery,
Serpentine, WA.**

**Report on Visit to Bodhinyana Buddhist Monastery, Kingsbury Drive,
Serpentine**

21Jan98

**School of Environmental Science, Division of Science and Engineering, Murdoch
University, Perth**

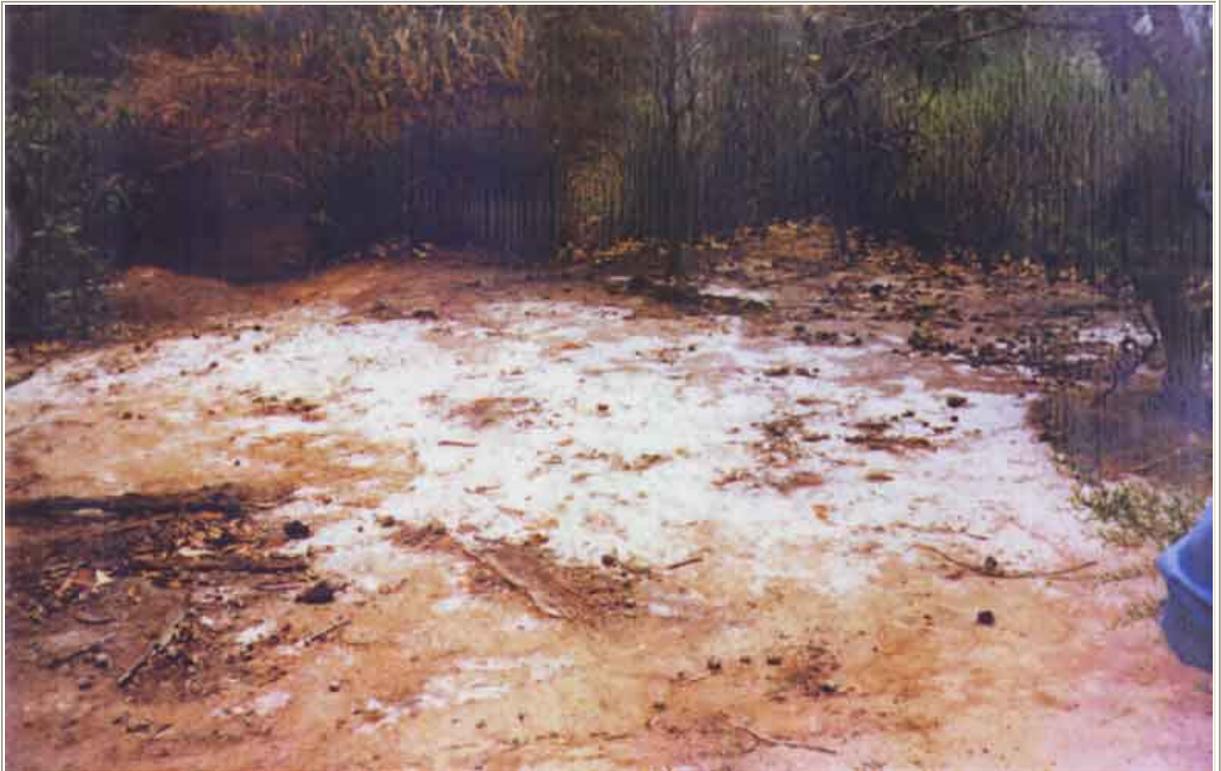
As the salinity issue will be inevitably linked to groundwater flow into the dams and groundwater discharge at the soil surface, indications of seepage were sought. Signs of seepage into Top Dam were found immediately up-slope of the present water level in the dam, with areas of salt inflorescence observed (see Salt Scald below). Reeds, usually associated with areas of groundwater discharge, were also present. There was an exposure of granite rock associated with the wall of Top Dam suggesting that there could be a granite rock bar across the valley which would act as a barrier to

Salt
Scald
above
the Top
Dam
Looking
East

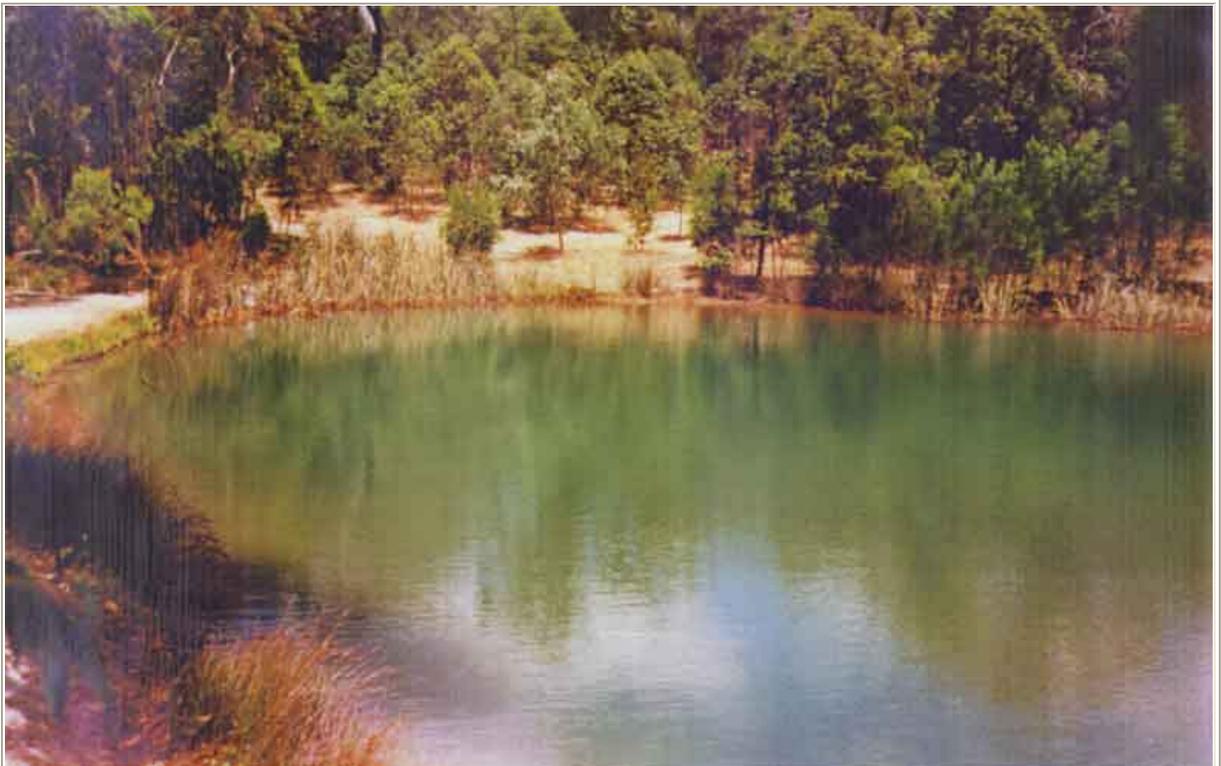
3.2 Dams: The Top Dam (see I on Figure 1 and picture below) existed when the property was acquired for the monastery in 1983. The Middle Dam (II on Figure 1), downslope but adjacent to Top Dam, was constructed by the Monastery in April 1993 to receive the winter overflow from the Top Dam. It has been observed that the water level in the Top Dam does not appear to decline as might be expected as water is removed.

Top
Dam
Looking
East

4.3 The observation of the fairly constant water level in Top Dam suggests that there is a significant volume of groundwater seeping into the dam. This would carry salt into the dam and allow an increase in salinity following the refilling of the dam with runoff water during the winter months. Evaporation would contribute to the increase in salinity, but with a smaller impact than the seepage of saline groundwater into the dam.

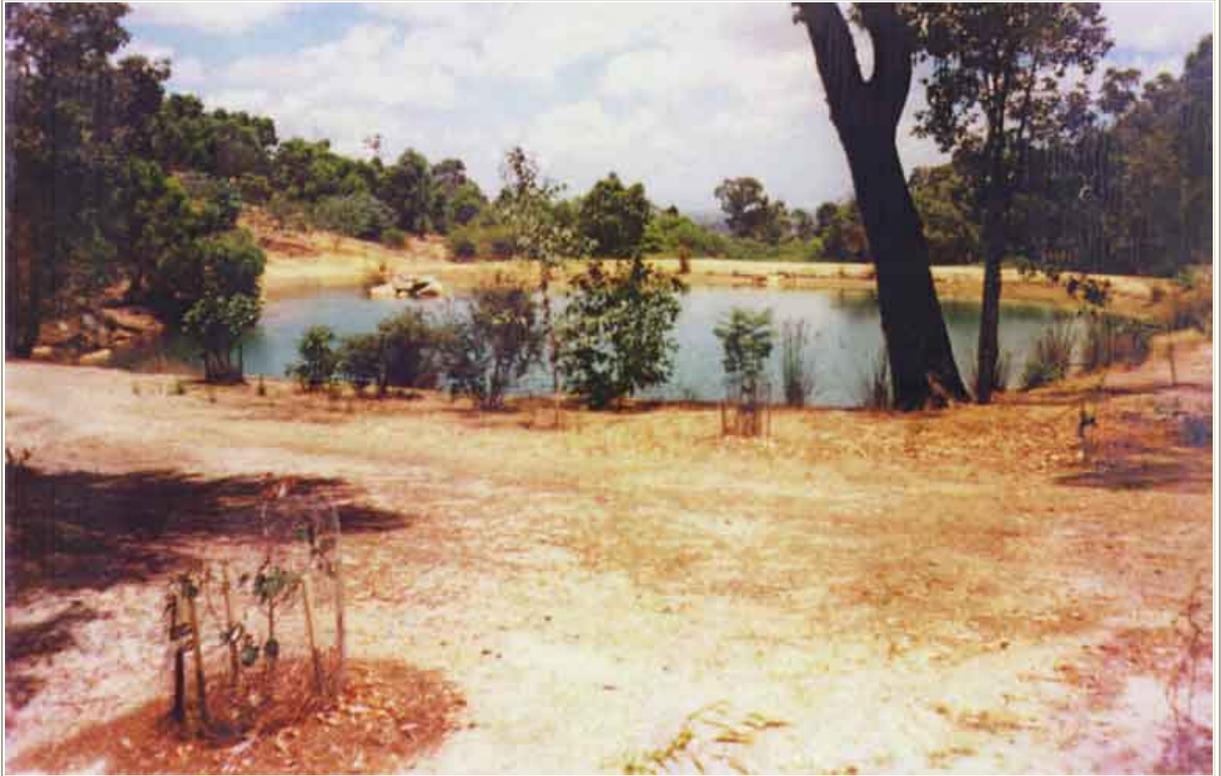
groundwater flow in the valley at the location of Top Dam. This would explain the groundwater discharge at the surface at the dam location. Middle Dam was located on an area known to be a wet seepage area. To the south-east of the dam an area of moist dark coloured soil was observed which identified an area of groundwater seepage. There was no information available, and no wells or dug holes available, to determine the salinity of the groundwater in any of the observed seepage locations.

Middle
Dam
Looking
West

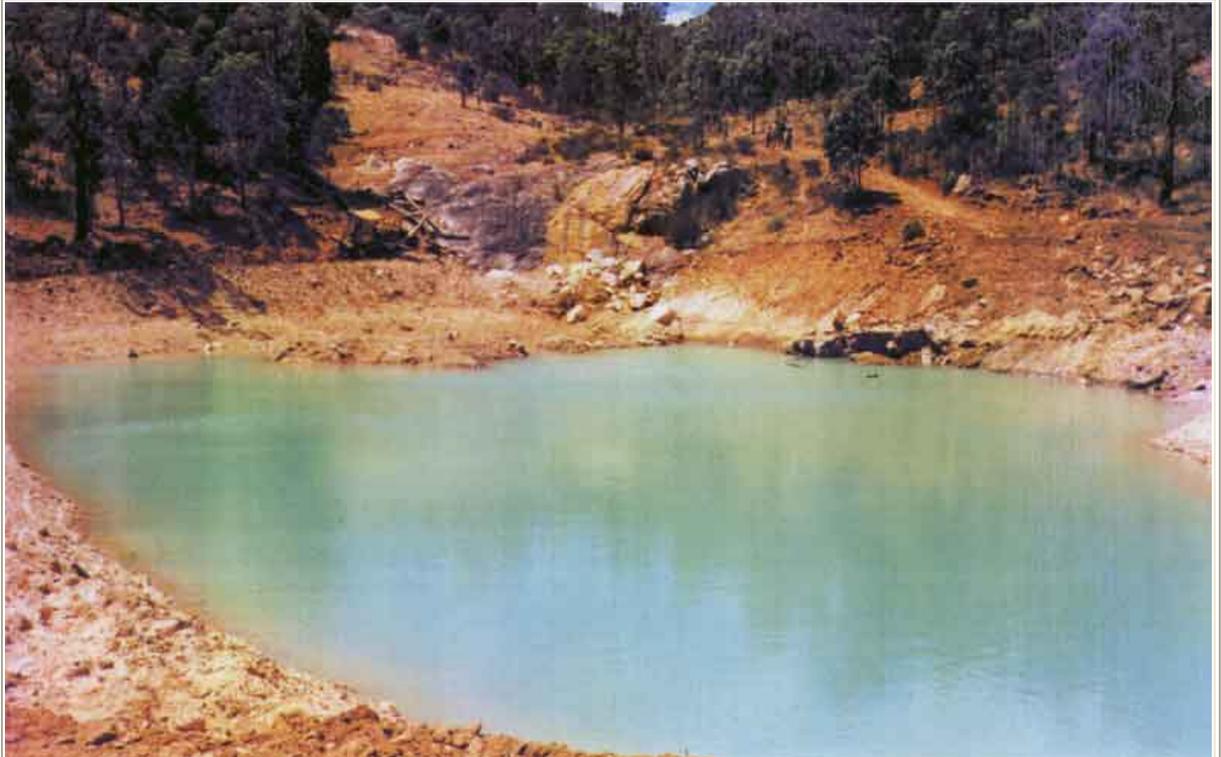
Bottom Dam is a new dam built in June/July 1997 about 200 metres down the valley from Top Dam and Middle Dam. Within a fortnight of completion of construction the dam filled to overflowing. The site has a vertical granite face on the northern side into which the earthen wall of the dam is butted. As would be expected there is seepage coming from the interface of the dam wall and the granite face. On the eastern side of the dam there is another vertical granite face above the level of the dam where flow in the creek forms a waterfall into the dam. Problems with scouring during overflow of the dam are being attended to, and further earthworks undertaken to correct the problem of inaccurate levels at the top of the dam wall. It was recommended that a concrete and rock spillway be designed and constructed to handle the overflow from this dam and to avoid the potential damage to the dam wall by scouring during overflow. Professional engineering advice should be sought on this matter to avoid a catastrophe.

Bottom
Dam
Looking
East
